# PEOPLE'S CHOICE INSPECTIONS LLC.

# FOUNDATION INSPECTION

1000 Elm Street Clayton, NC 27527

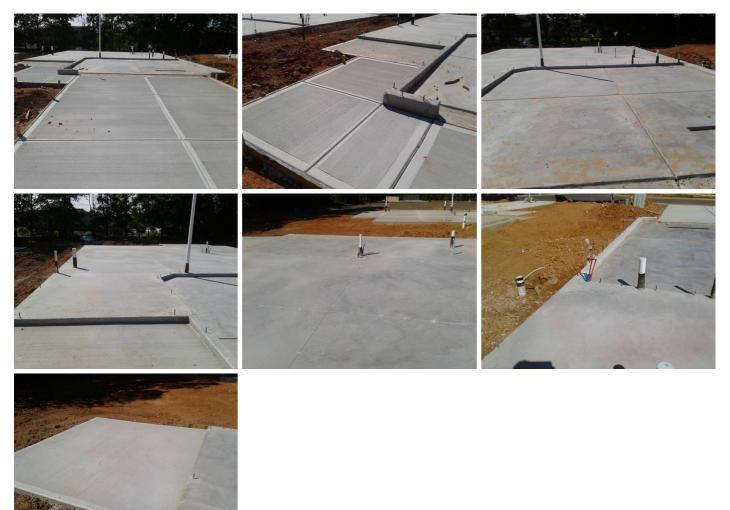
Front service walkway concrete forms still present . Unable to identify sides due to this

Concrete Slab

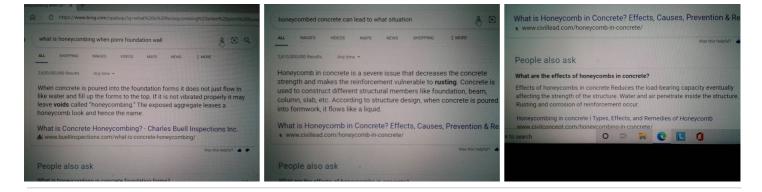
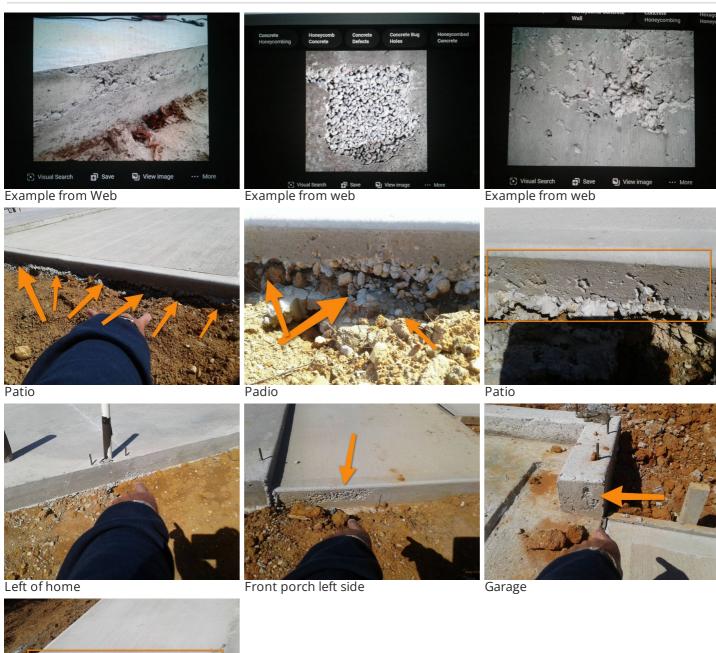
Patio

## **EXPOSED AGGREGATE STONE (HONEYCOMBING)**

Exposed aggregate stone in a foundation can lead to future foundation issues such as future cracks and busted sections. One of the main contributors to this is moisture. When water freezes it expands causing sections to bust or crack. Recommend sealing these areas to help avoid future issues.

Recommendation

Contact a foundation contractor.
