PEOPLE'S CHOICE INSPECTIONS LLC.

PRE-DRYWALL INSPECTION

1000 Elm Street
Raleigh, NC 27610

John Doe
MAY 16, 2022

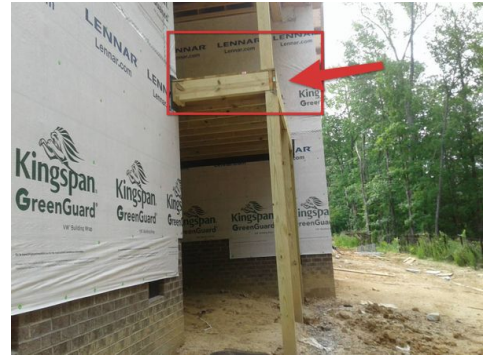
4.2.1 Exterior Add-Ons

GUARDRAILS MISSING

DECK

Guardrails are **REQUIRED** when a landing or walking surface is above 30 inches from the ground. Recommend that a licensed contractor install.

Recommendation

Contact a qualified deck contractor.

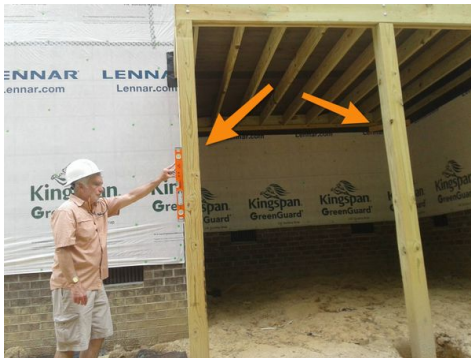
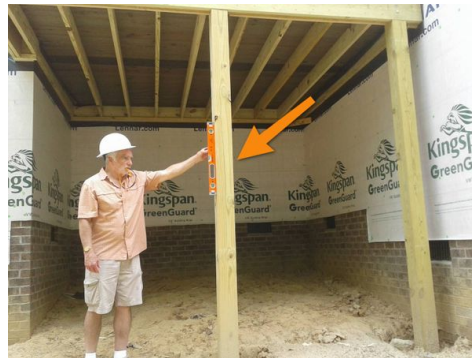
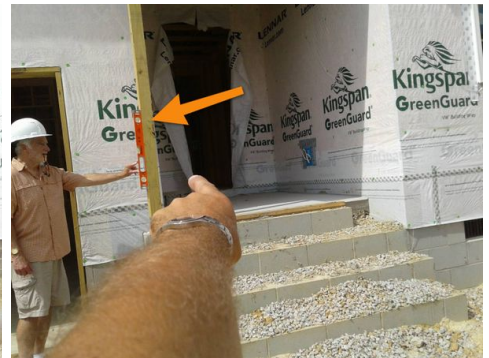
4.2.2 Exterior Add-Ons

SUPPORT POSTS NOT LEVEL

FRONT PORCH AWNING SUPPORT, BACK DECK SUPPORT POSTS

Recommendation

Contact a qualified deck contractor.

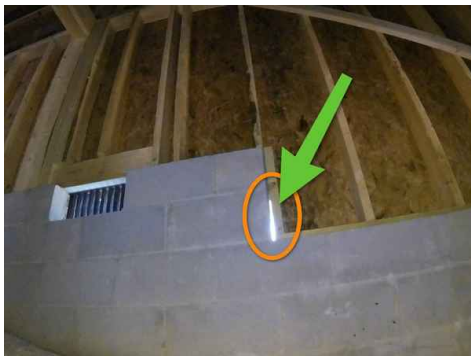
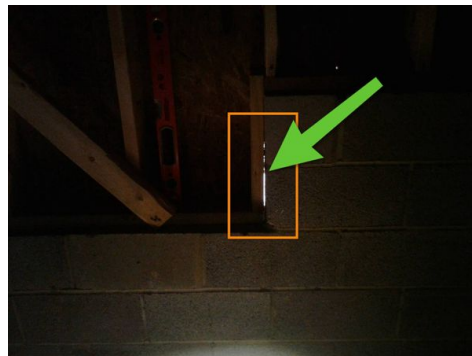
4.3.1 Wall Sheathing

DAYLIGHT VISIBLE

OSB IN SOME SPOTS LOCATED IN THE CRAWL SPACE AREA

Recommendation

Contact your builder.

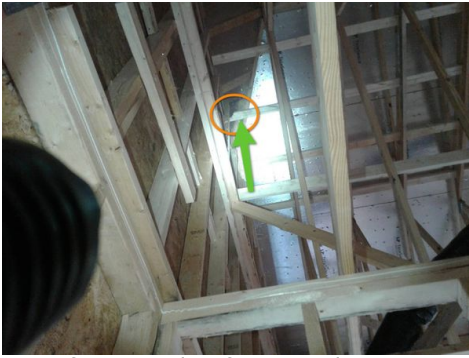
5.1.1 Ceiling Framing

CEILING FRAMING IMPROPERLY NOTCHED

ATTIC

Seen from inside of pantry closet looking up

Recommendation

Contact your builder.

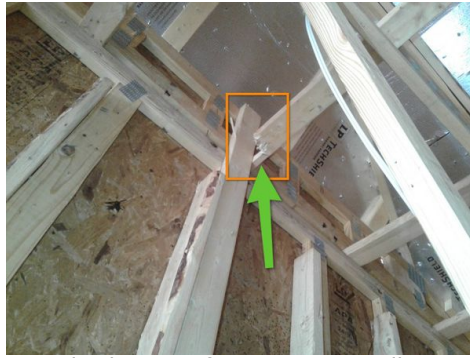
Seen looking up from master walk in closet

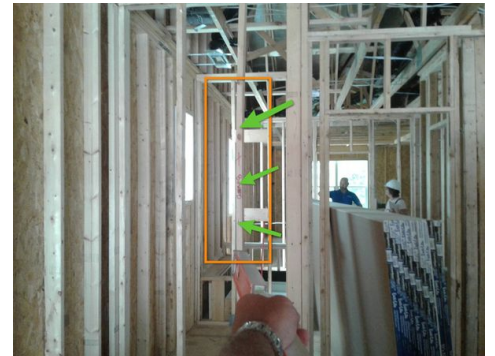
5.2.1 Walls & Columns Plumb/Bowed

BOWED STUDS

MASTER BEDROOM CLOSET

The Framed Wall had bows in various areas at the time of inspection. We recommend to inspect and repair prior to drywall.

Observation: The wall is bowed.

Performance Guideline: Walls will not bow more than 1 /2 inch out of line within any 32 inch horizontal measurement, or 1 /2 inch out of line within any 8 foot vertical measurement.

Corrective Measure: The contractor will repair the wall to meet the performance guideline.

Recommendation

Contact your builder.

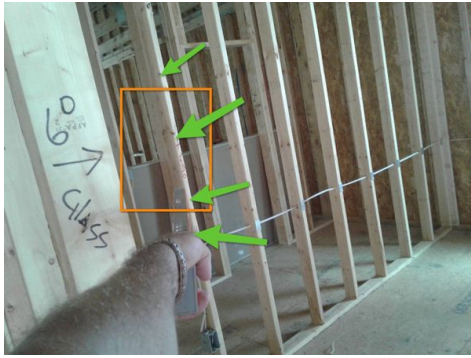
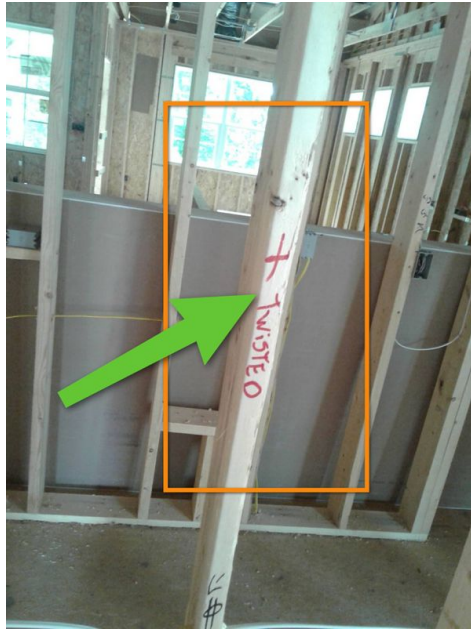
5.2.2 Walls & Columns Plumb/Bowed

TWISTED STUDS

OFFICE/FLEX ROOM

The Studs were twisted and should be replaced. These framing members will only get worse. We recommend to inspect and repair/replace.

Recommendation

Contact your builder.

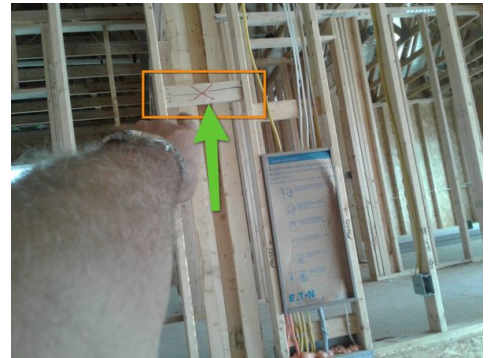
5.2.3 Walls & Columns Plumb/Bowed

DAMAGED BLOCKING

GARAGE

Garage blocking split

Recommendation

Contact your builder.

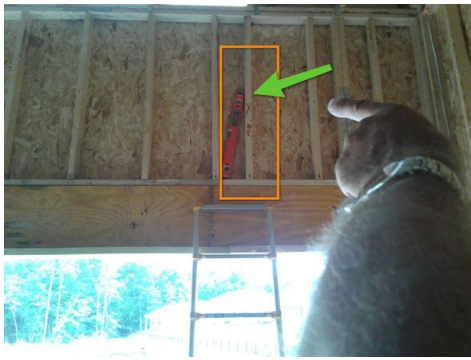
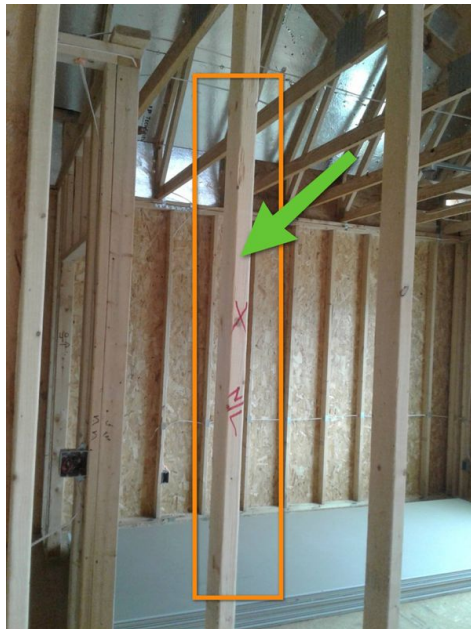
5.2.4 Walls & Columns Plumb/Bowed

STUDS NOT LEVEL

GARAGE, FRONT BEDROOM

Front bedroom wall stud at entry hallway

Recommendation

Contact your builder.

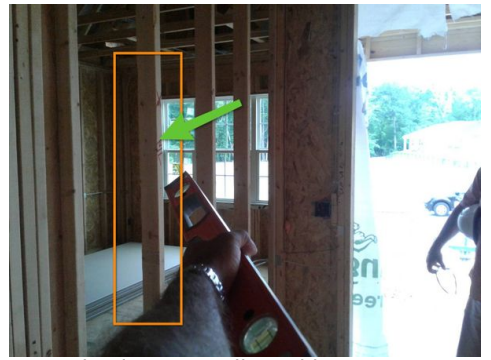
Front bedroom wall stud location

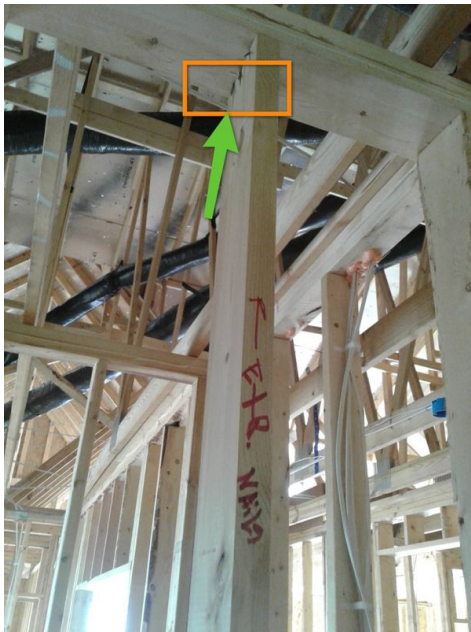
5.2.5 Walls & Columns Plumb/Bowed

STUDS NOT ATTACHED PROPERLY

KITCHEN,

Kitchen pantry wall stud

Recommendation

Contact your builder.

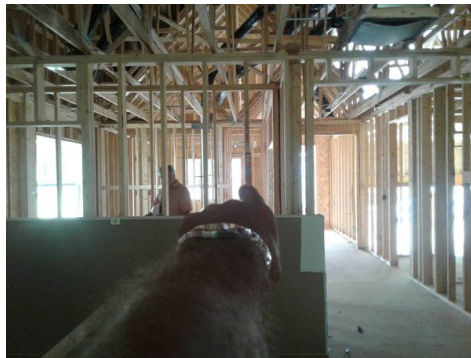
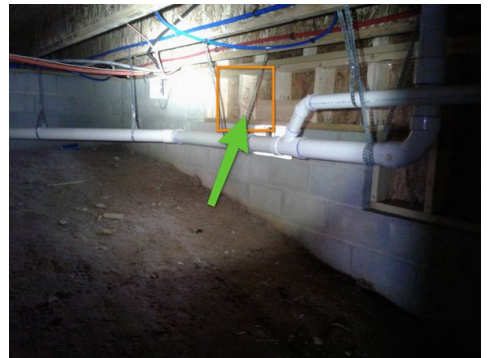
Exposed nails missing stud. Crawl space

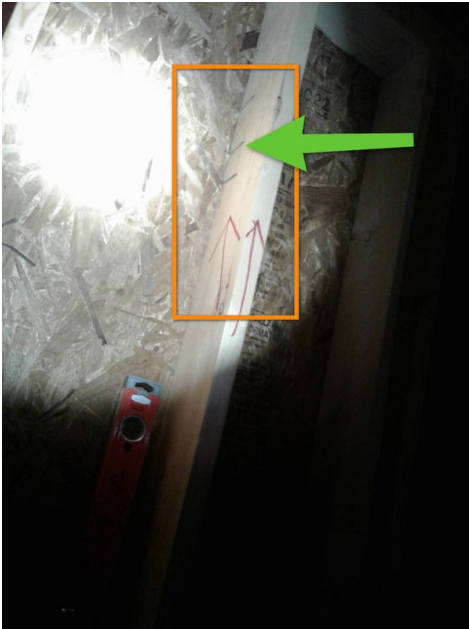
Exposed nails back left of crawl space stud. Right side of left rear pocket

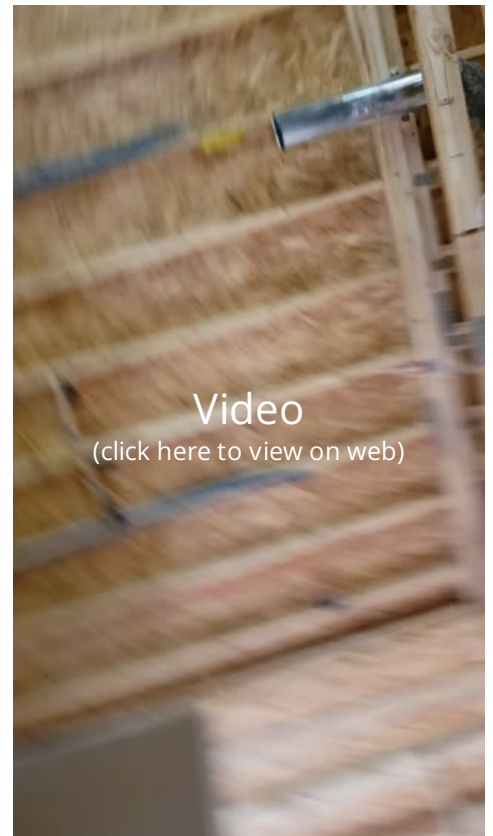
5.6.1 Cabinet/Vanity Blocking Installed

MISSING CABINET BLOCKING

The Cabinet Blocking was not installed. This helps to make the cabinet installation easier and stronger. We recommend to inspect and install.

Recommendation

Contact your builder.

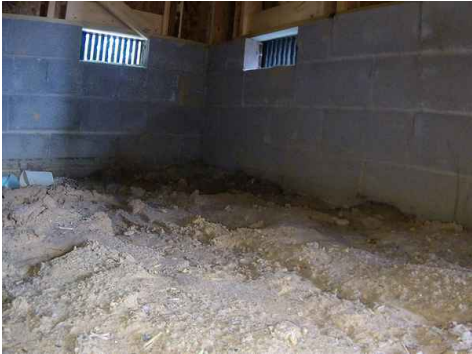
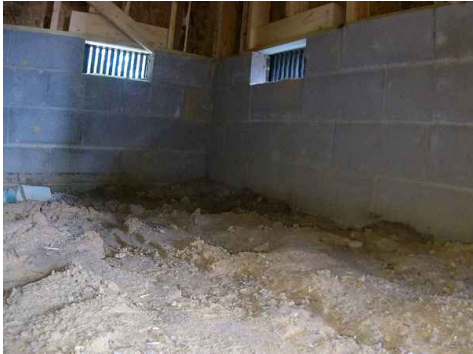
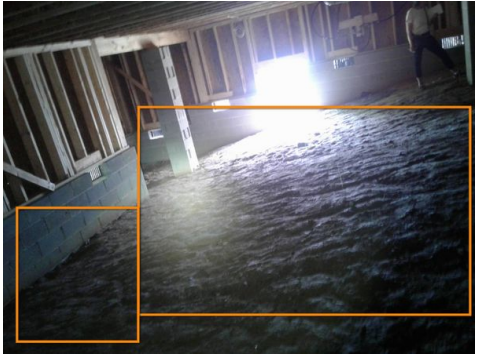
crawl space dirt floor has water run off Traughs within the floor. recommend that a sump be installed

Recommendation
Contact your builder.

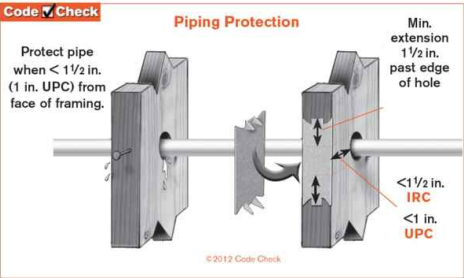
Plumbing Pipe Nail Guard Diagram

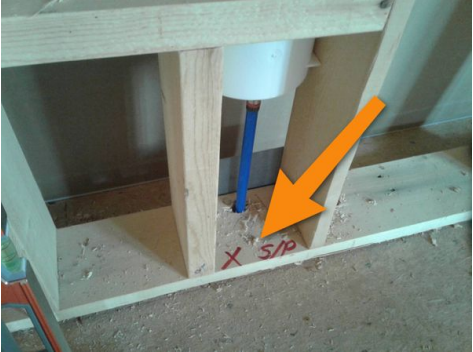
Nail Guards were missing in various locations at the time of inspection. Provided a few reference photos. Builder should inspect entire home and install as per code requirements.

Fridge plumbing

Recommendation
Contact your builder.

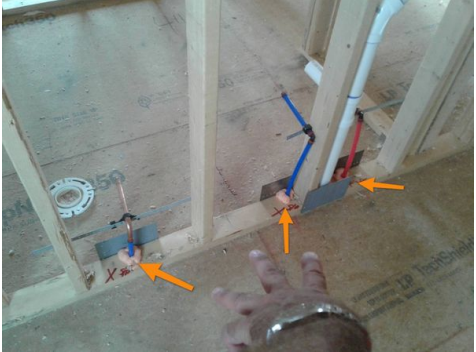
Front bedroom bathroom

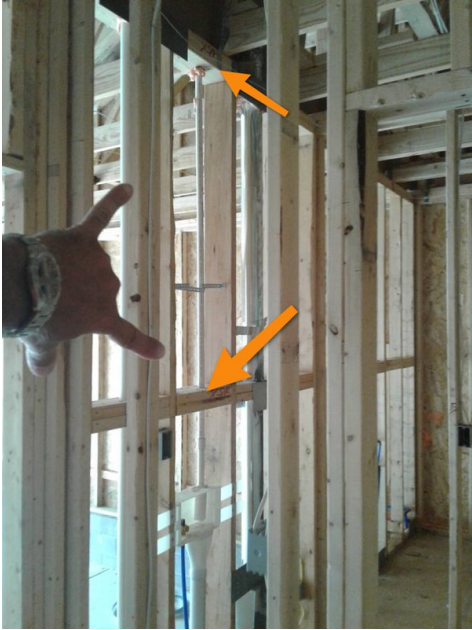
Laundry room

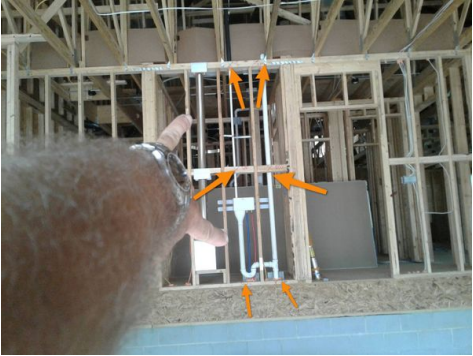
Garage
